**Existing Conditions (1999) Water Surface and Thalweg Profiles
Corresponding to Flood Peak Discharges**

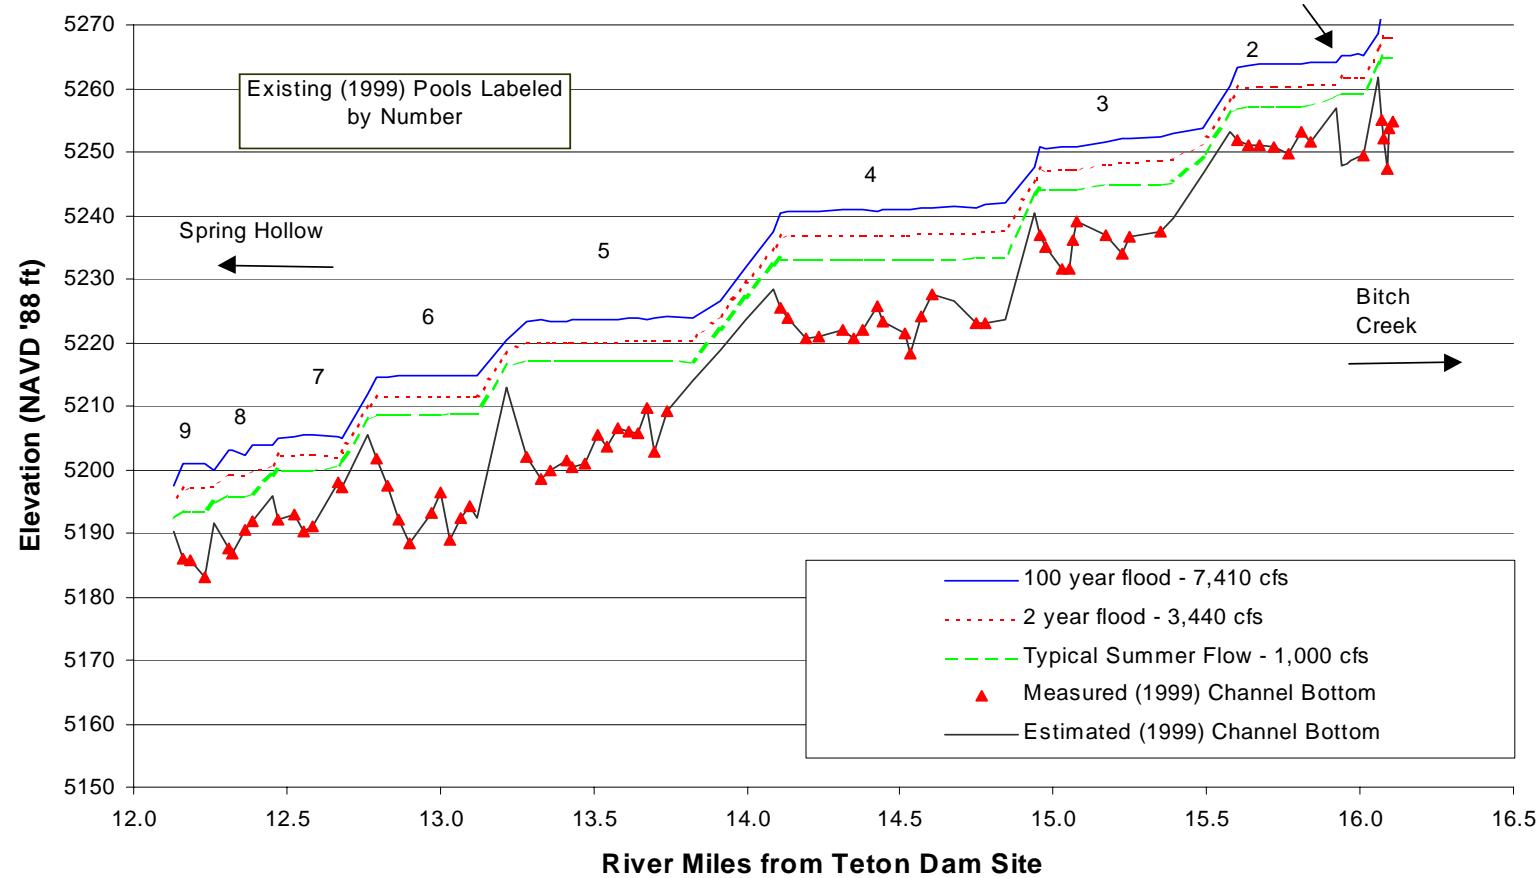
Figure H-1. Existing conditions (1999) water surface and thalweg profiles corresponding to a typical summer discharge and flood peak discharges (RM 12.1 to 16.1).

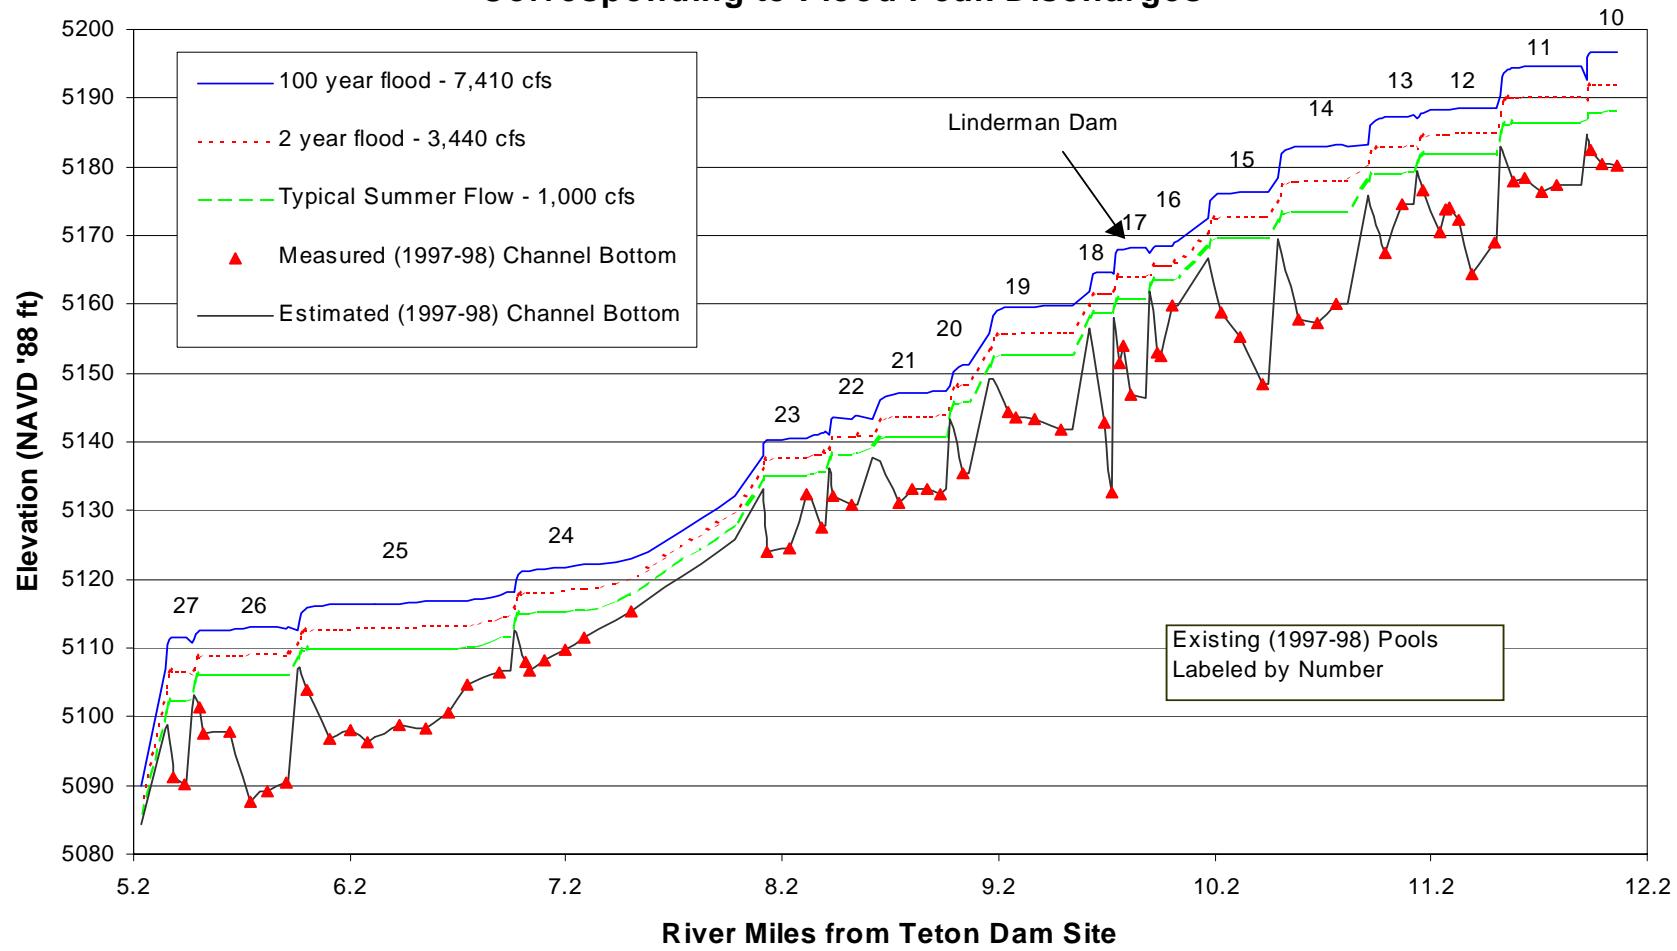
Figure H-2.—Existing conditions (1997-98) water surface and thalweg profiles corresponding to a typical summer discharge and flood peak discharges (RM 5 to 12.1).

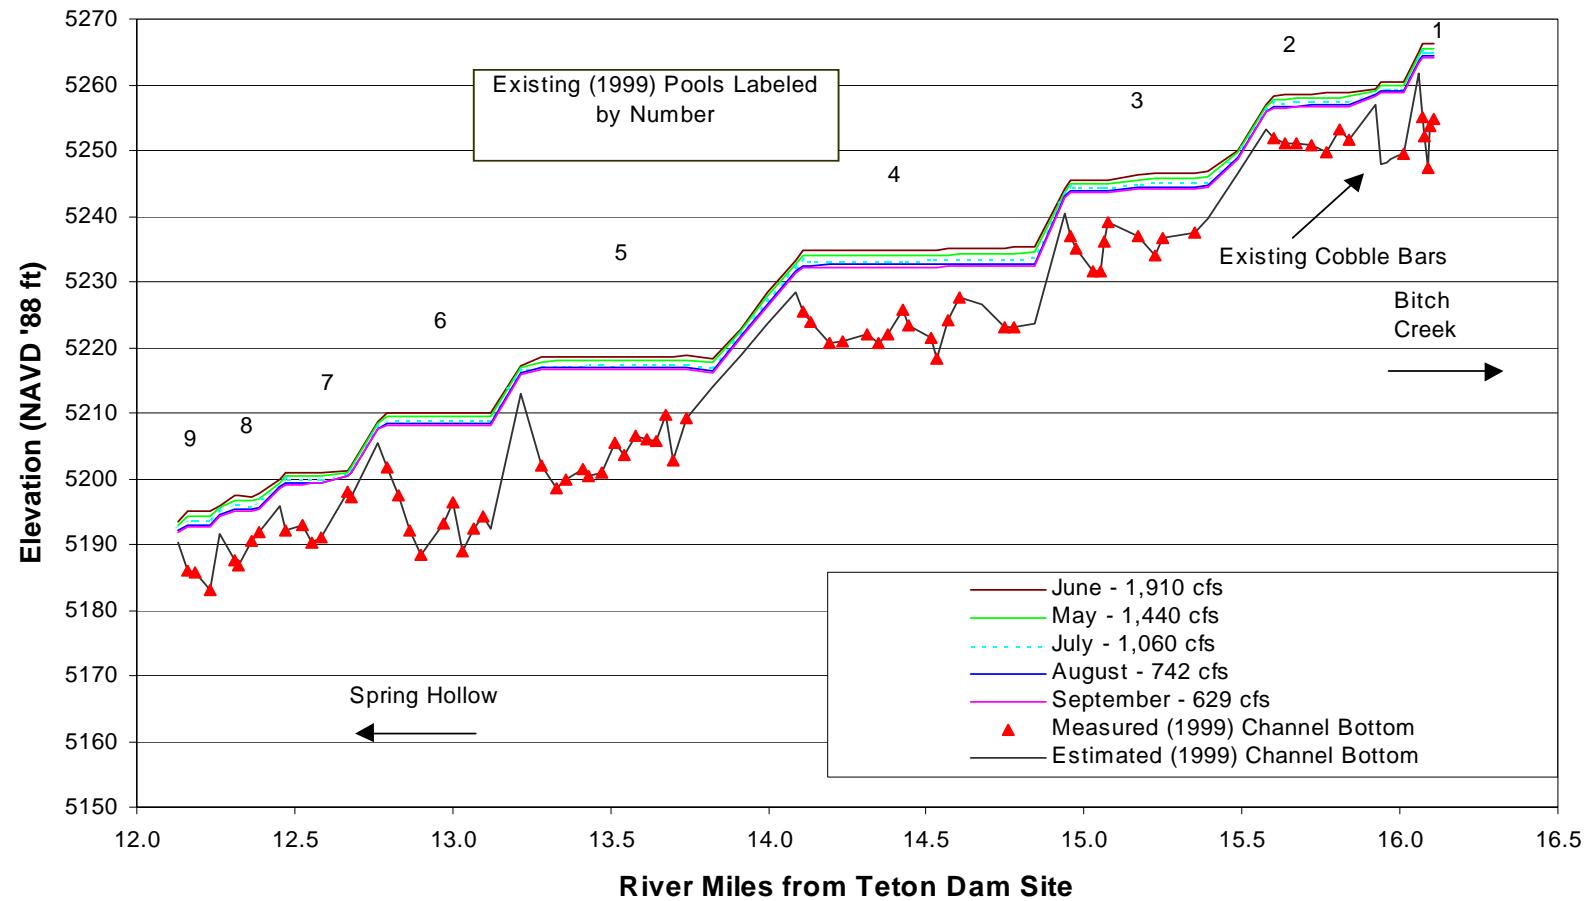
Figure H-3.—Existing conditions (1999) water surface and thalweg profiles corresponding to median summer discharges (RM 12.1 to 16.1).

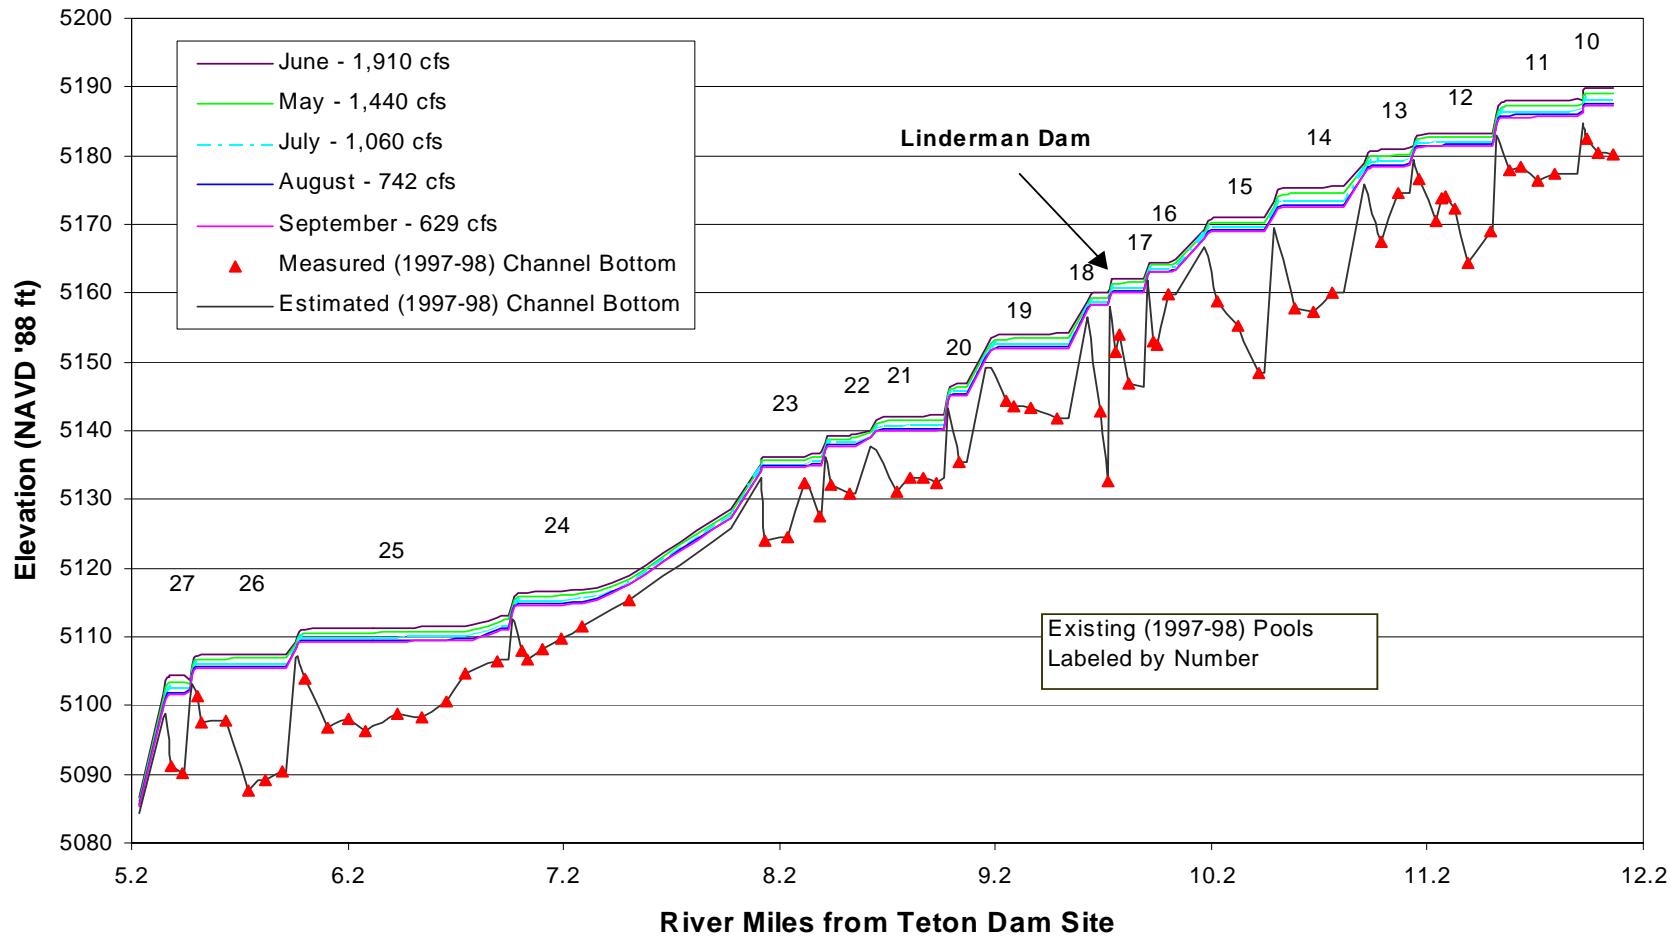
Figure H-4.—Existing conditions (1999) water surface and thalweg profiles corresponding to median summer discharges (RM 5 to 12.1).

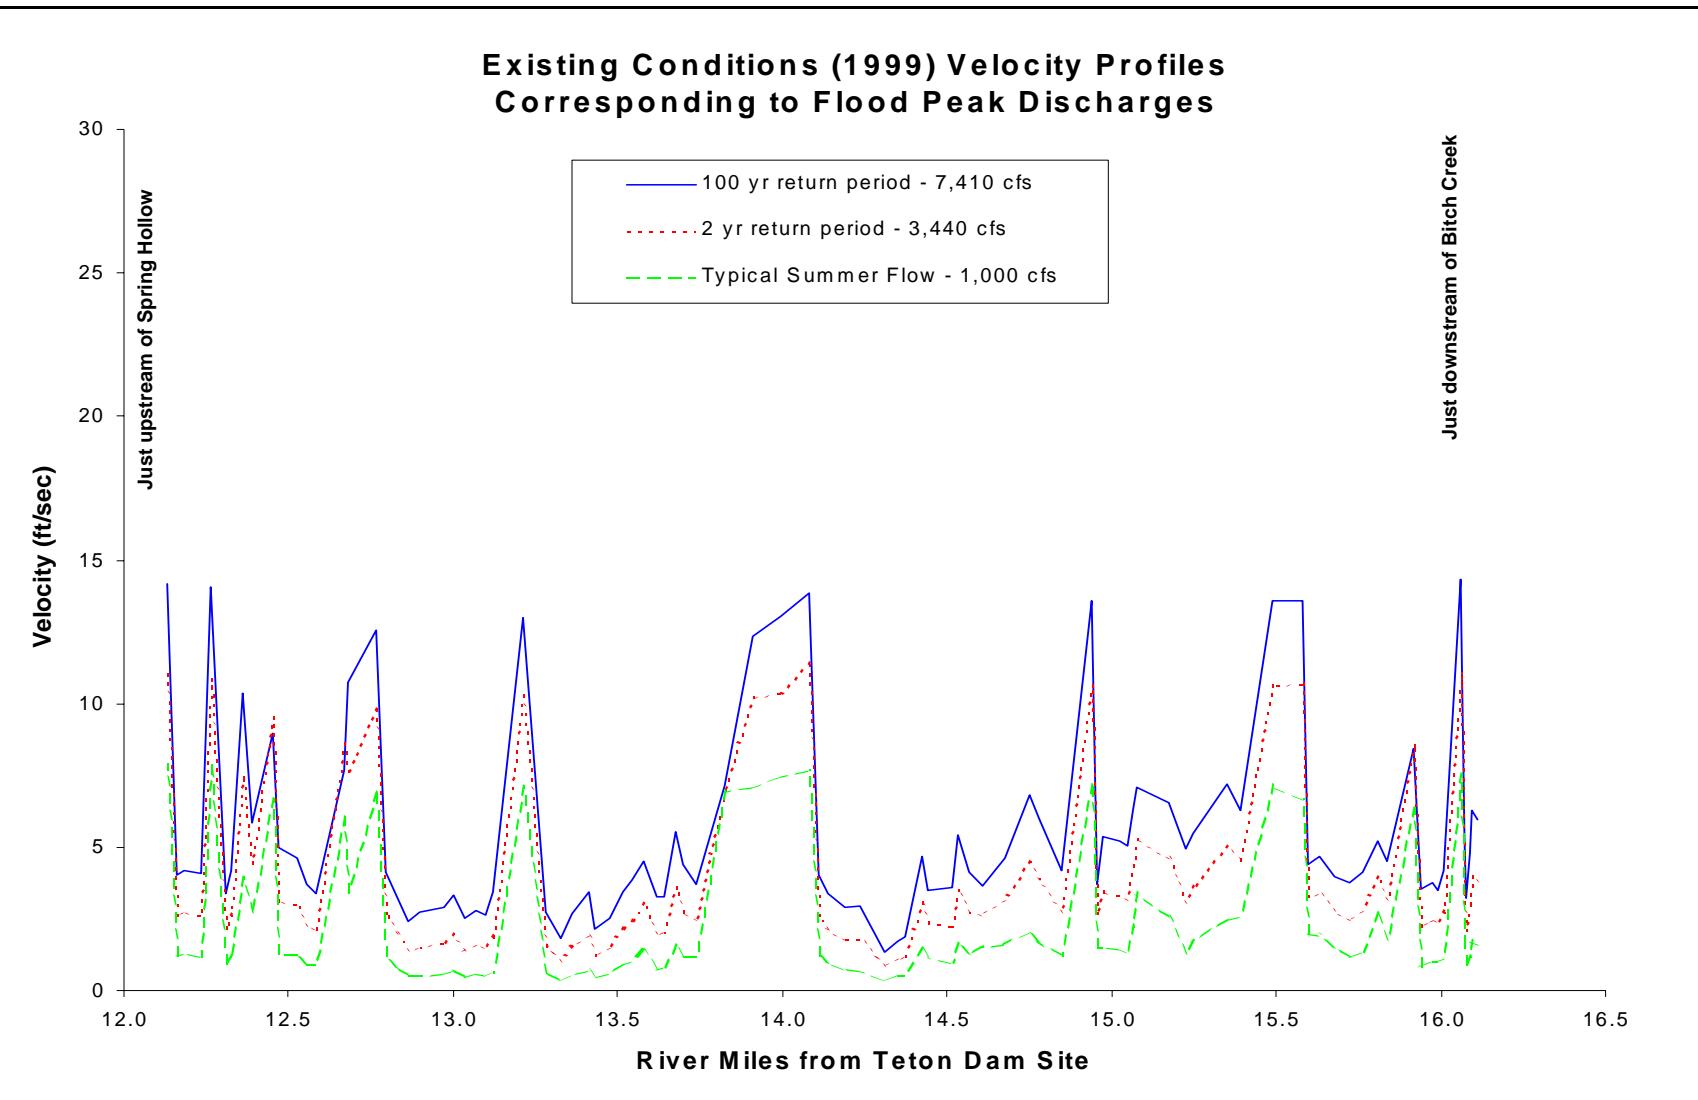
Figure H-5.—Existing conditions (1999) velocity profiles corresponding to a typical summer discharge and flood peak discharges (RM 12.1 to 16.1).

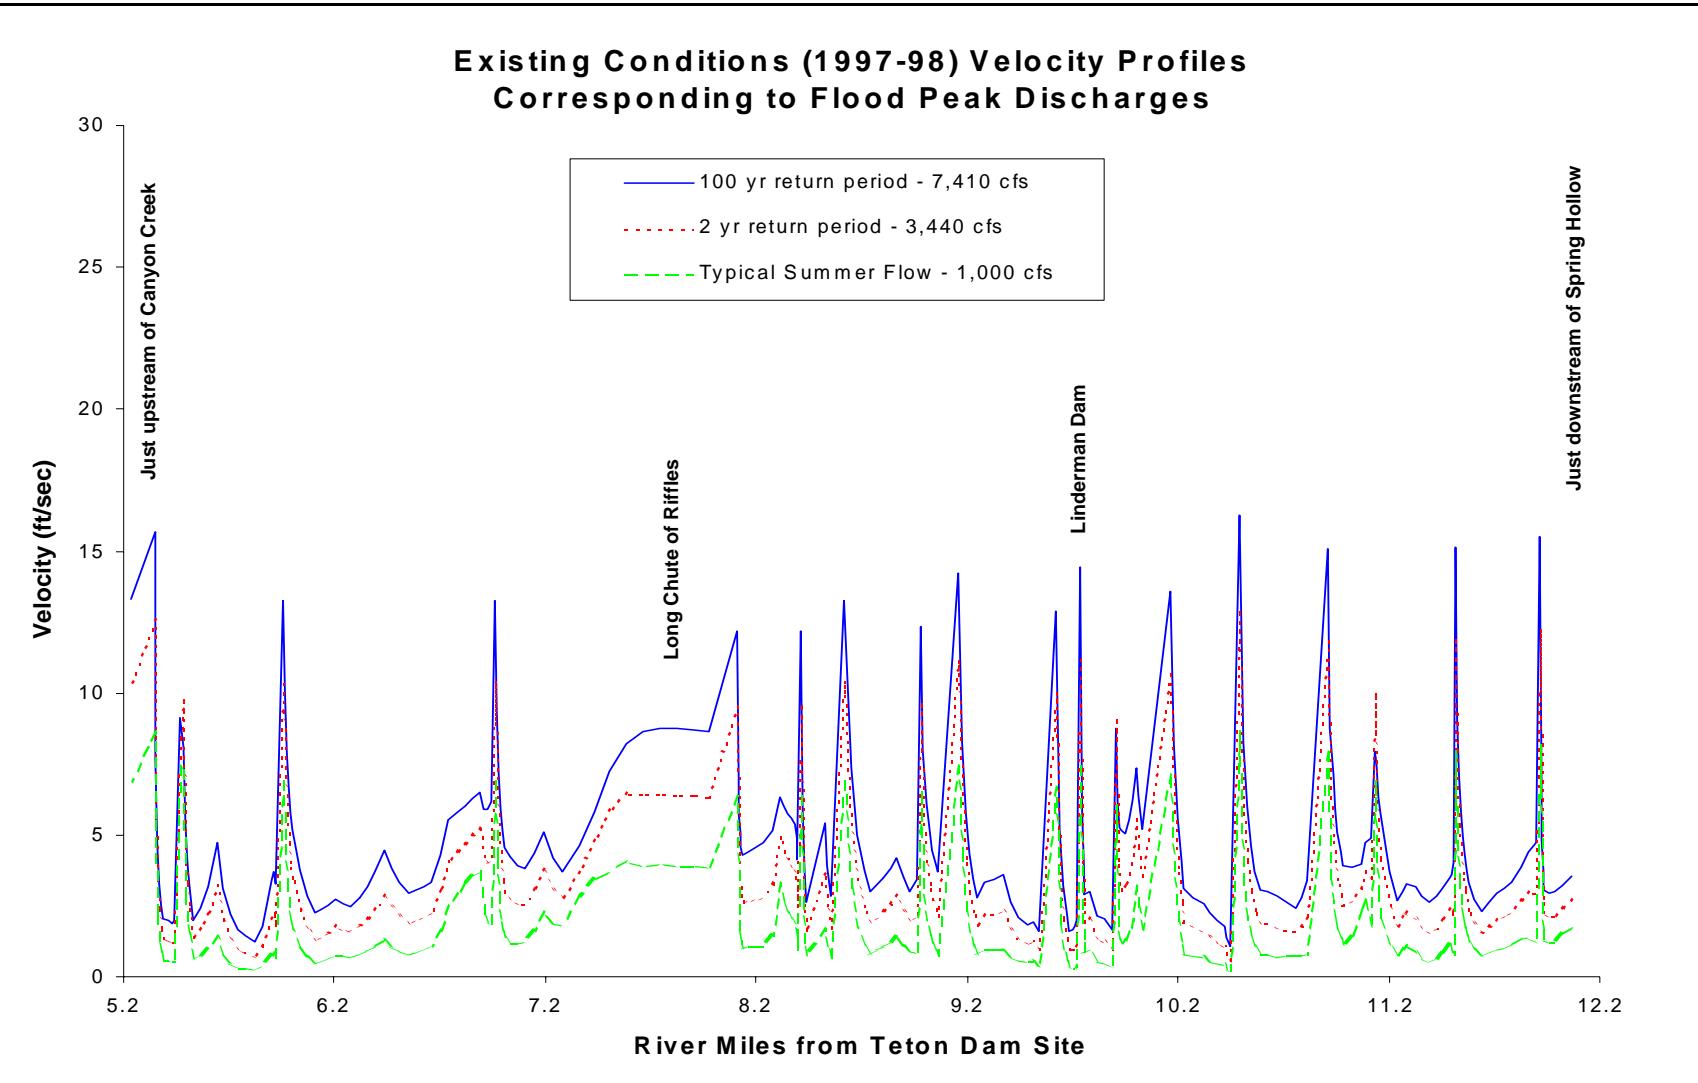
Figure H-6.—Existing conditions (1997-98) velocity profiles corresponding to a typical summer discharge and flood peak discharges (RM 5 to 12.1).

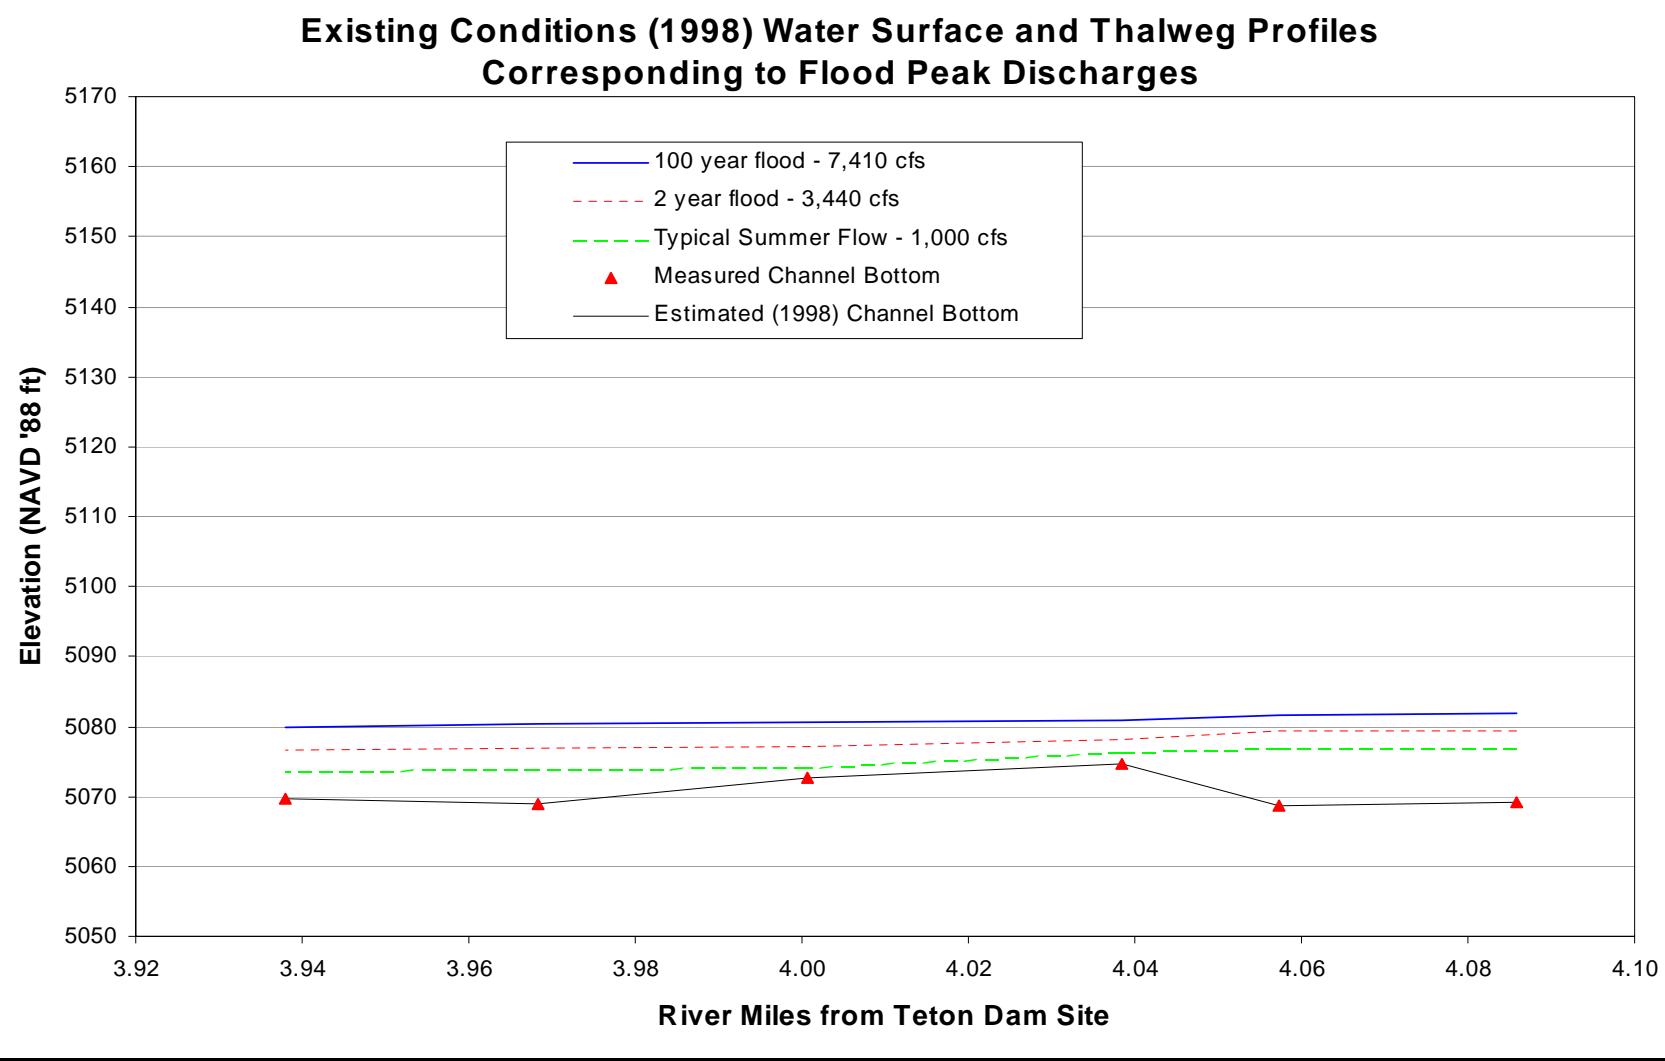
Figure H-7.—Existing conditions (1998) water surface and thalweg profiles corresponding to a typical summer discharge and flood peak discharges (RM 4).

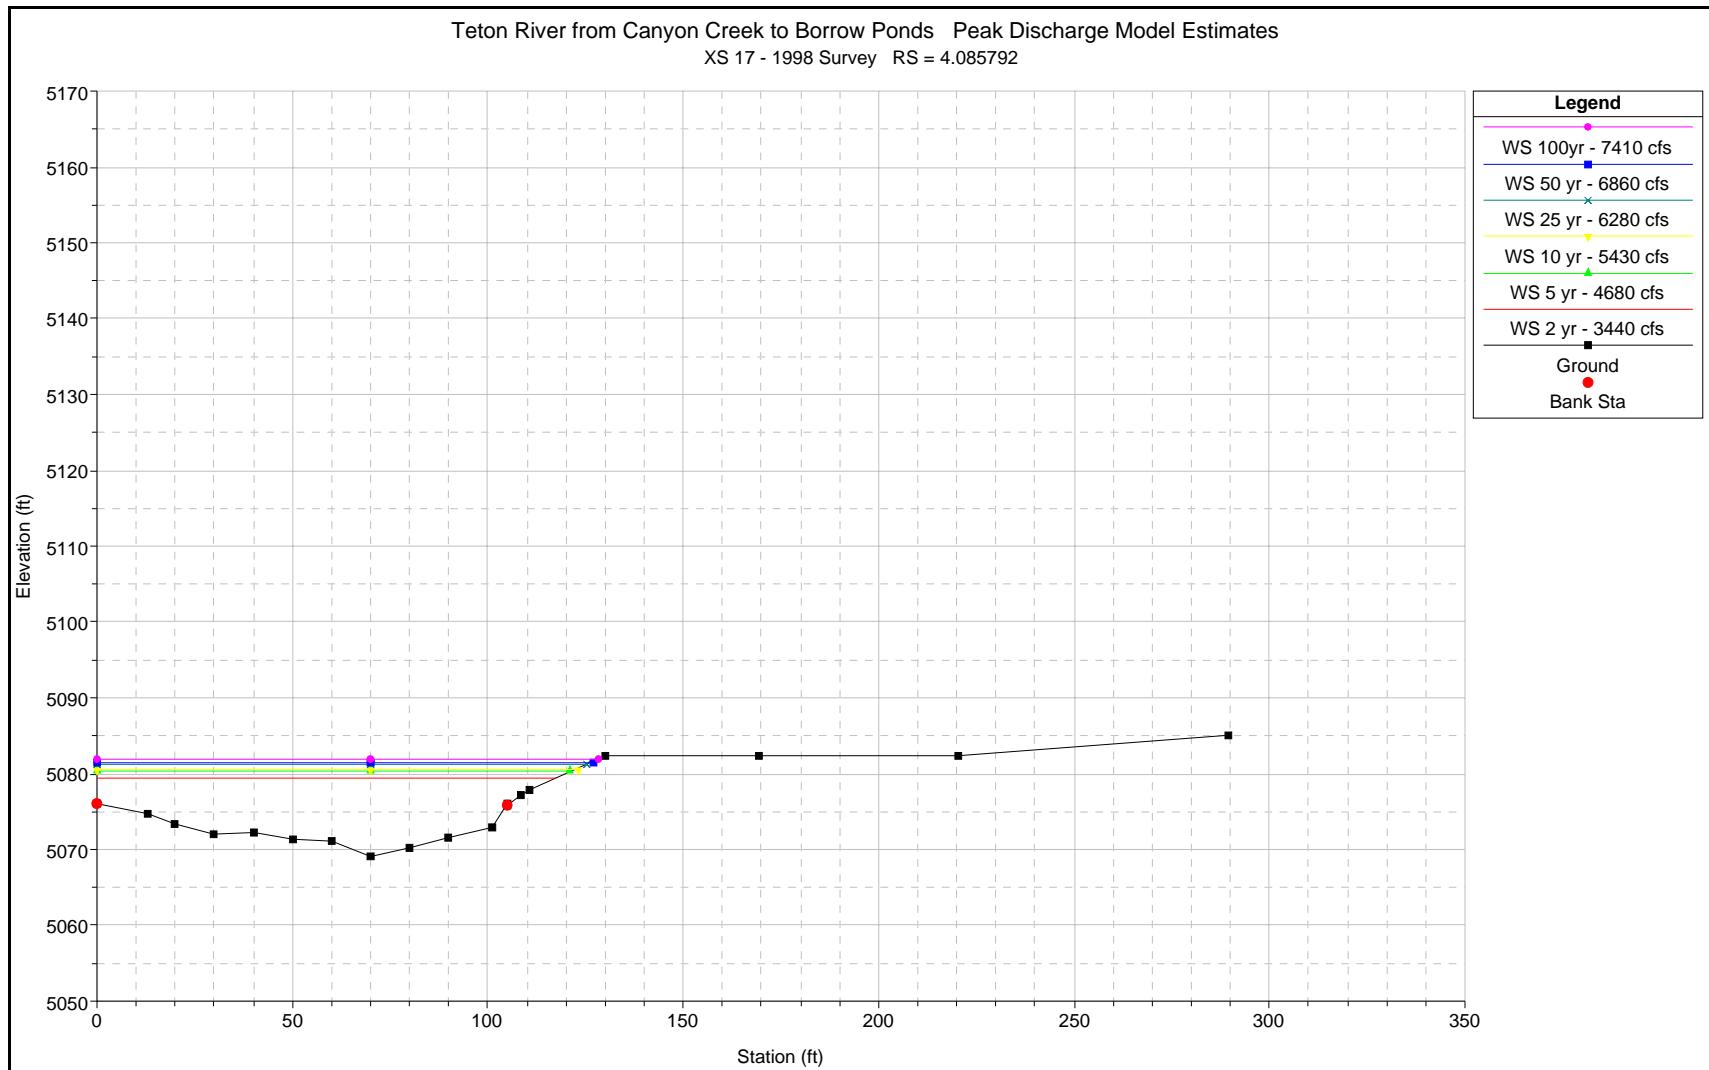
Figure H-8.— Computed water surface profiles corresponding to flood peak discharges at a section representative of Canyon Creek to Borrow Ponds reach (RM 4.086).

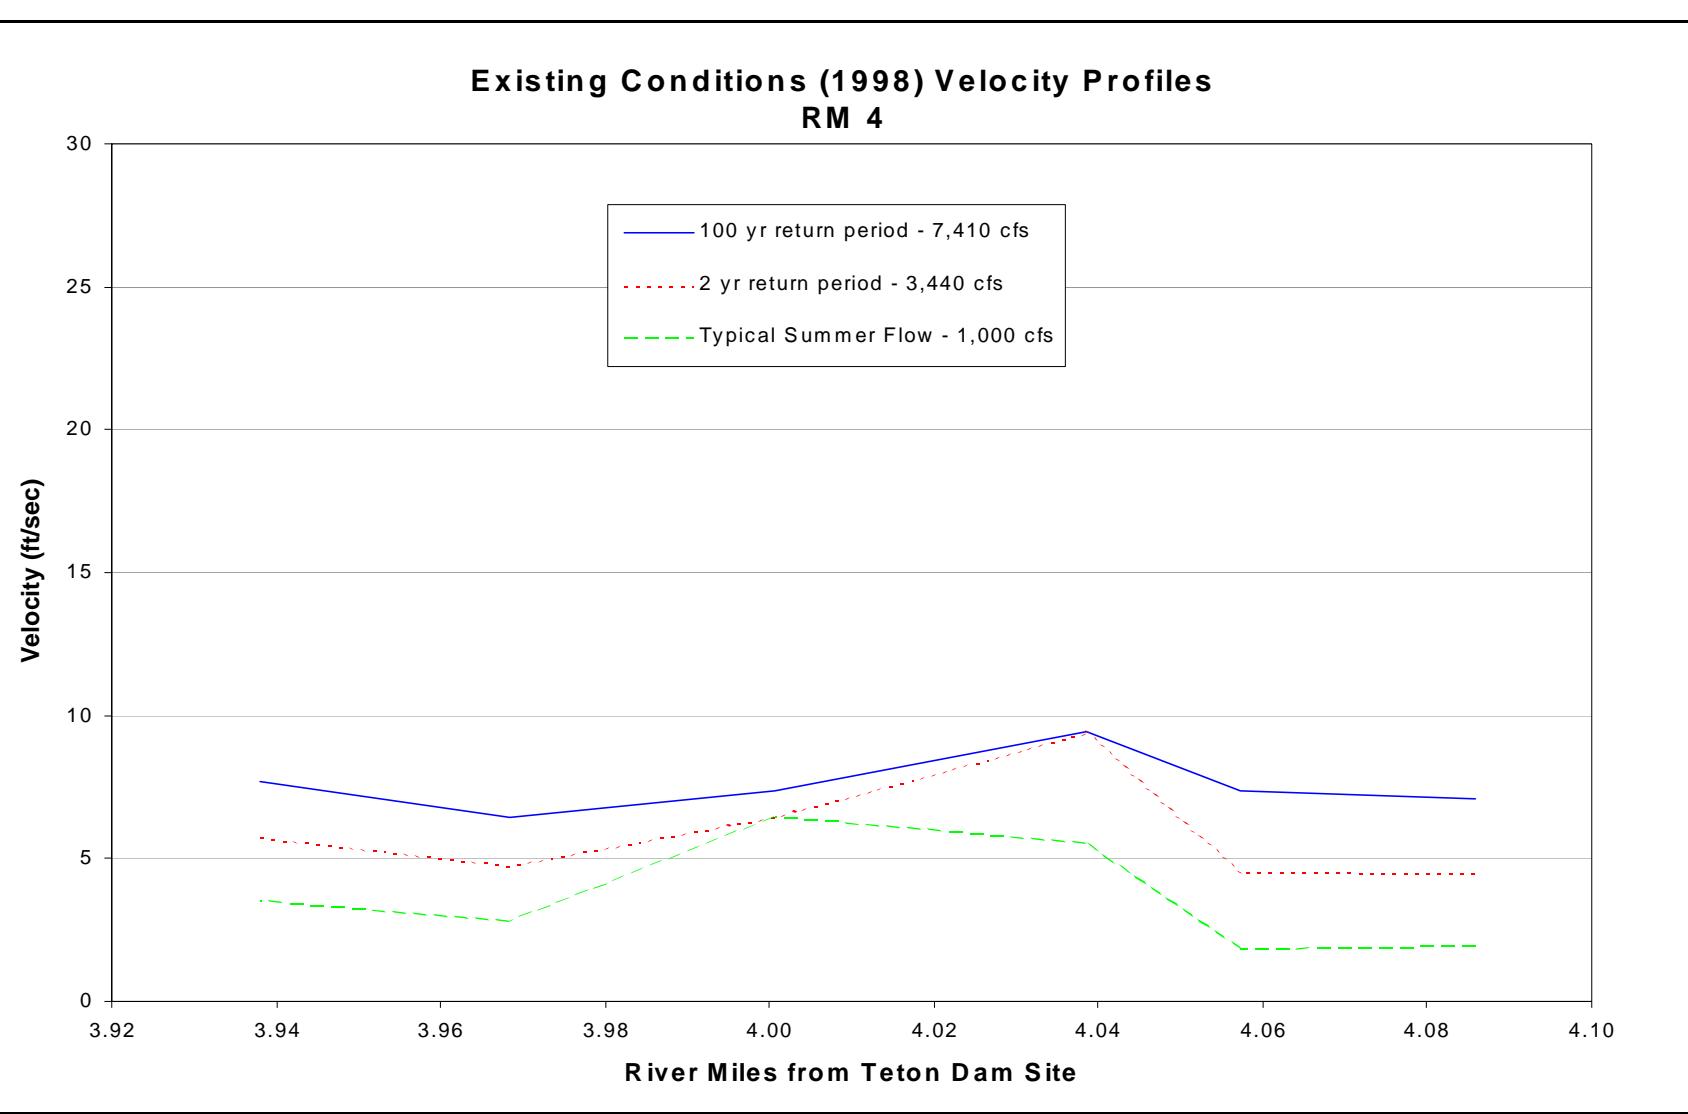
Figure H-9.—Existing conditions (1998) velocity profiles corresponding to a typical summer discharge and flood peak discharges (RM 4). In the riffle area (XS 4.04 and 4.00), the velocities for different discharges are similar because of the local cross-section geometry, where there is a large increase in river width and a small increase in water depth (see pages F-3 and F-4).

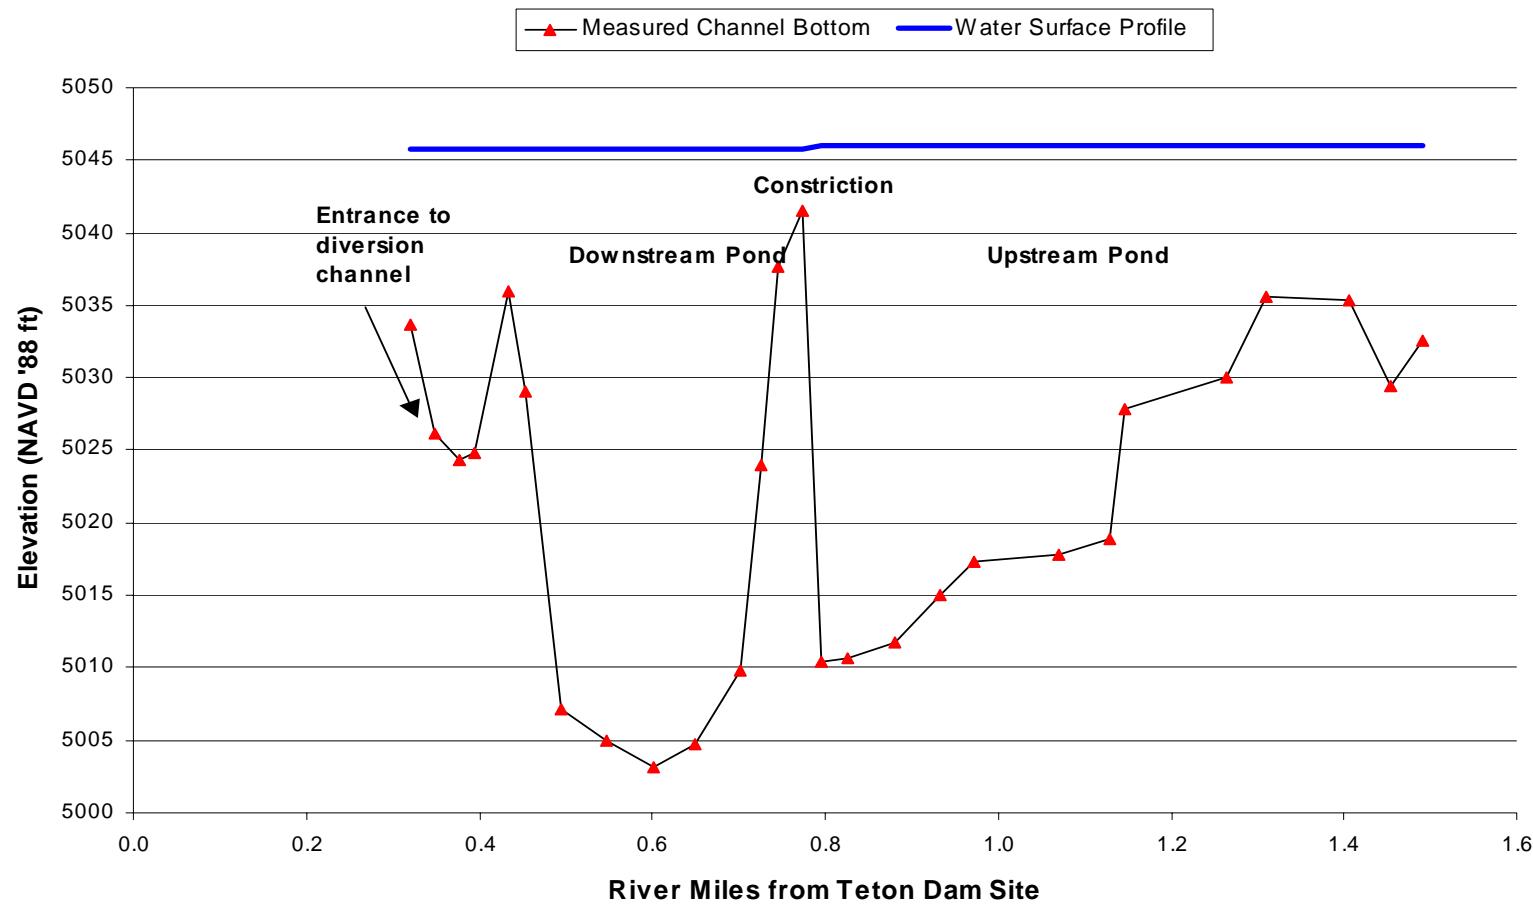
Existing Conditions (1997) Water Surface and Thalweg Profiles
Typical Summer Flow of 1,000 cfs

Figure H-10.—Existing conditions (1997) water surface and thalweg profile corresponding to a typical summer discharge(Borrow Ponds).

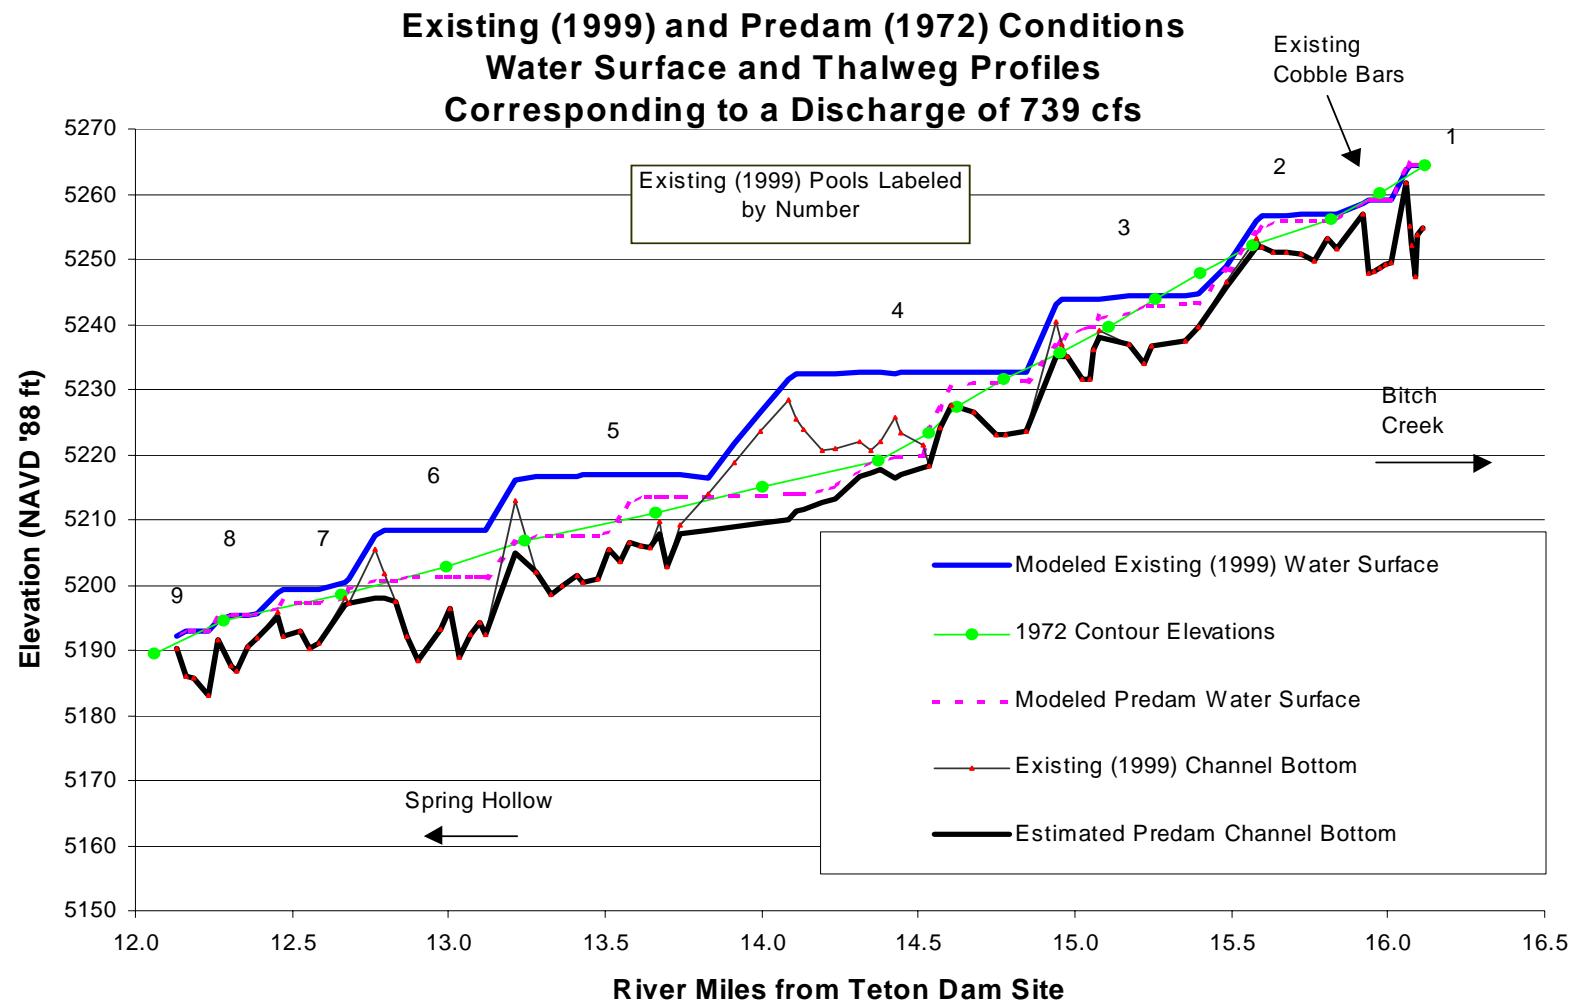
Figure H-11.—Comparison of existing conditions (1999) and predam (1972) water surface and thalweg profiles corresponding to a typical summer discharge (RM 12.1 to 16.1).

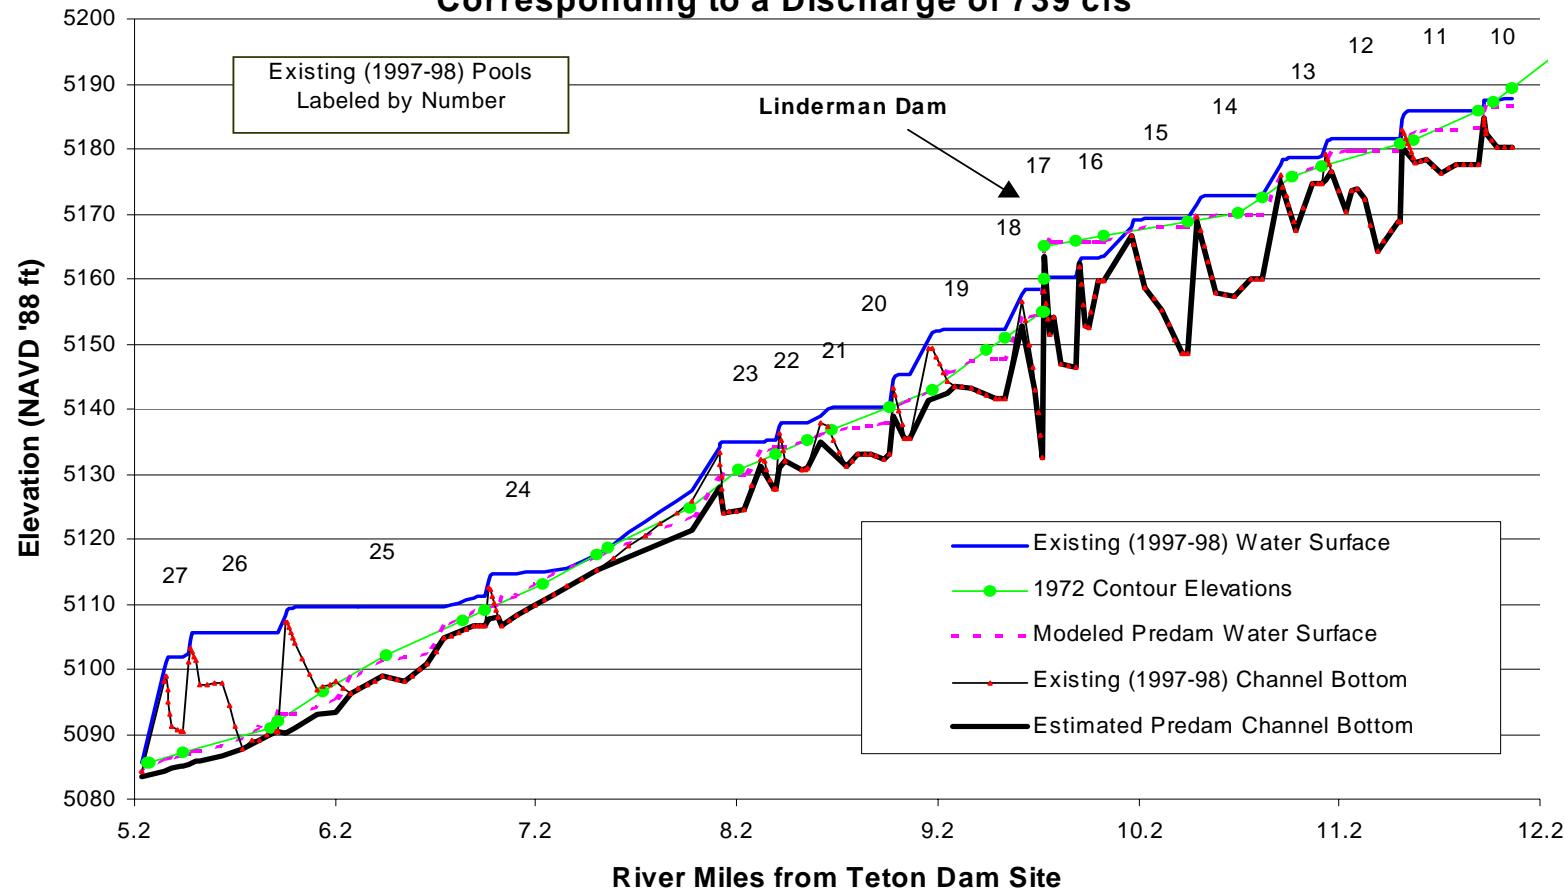
**Existing (1997-98) and Predam (1972) Conditions
Water Surface and Thalweg Profiles
Corresponding to a Discharge of 739 cfs**

Figure H-12.—Comparison of existing conditions (1997-98) and predam (1972) water surface and thalweg profiles corresponding to a typical summer discharge (RM 5 to 12.1).
